Dairy Industry Bungalow I (Building 159)--Beltsville Agricultural Research Center

Maryland Historical Trust Inventory Form
Maryland Comprehensive Historic Preservation Plan Data
Building 159 - P.G. #67-26
Beltsville Agricultural Research Center
Prince George's County, Maryland

DETERMINATION OF ELIGIBILITY REPORT
Dairy Industry Bungalow I--Building 159--P.G. #67-26
Beltsville Agricultural Research Center

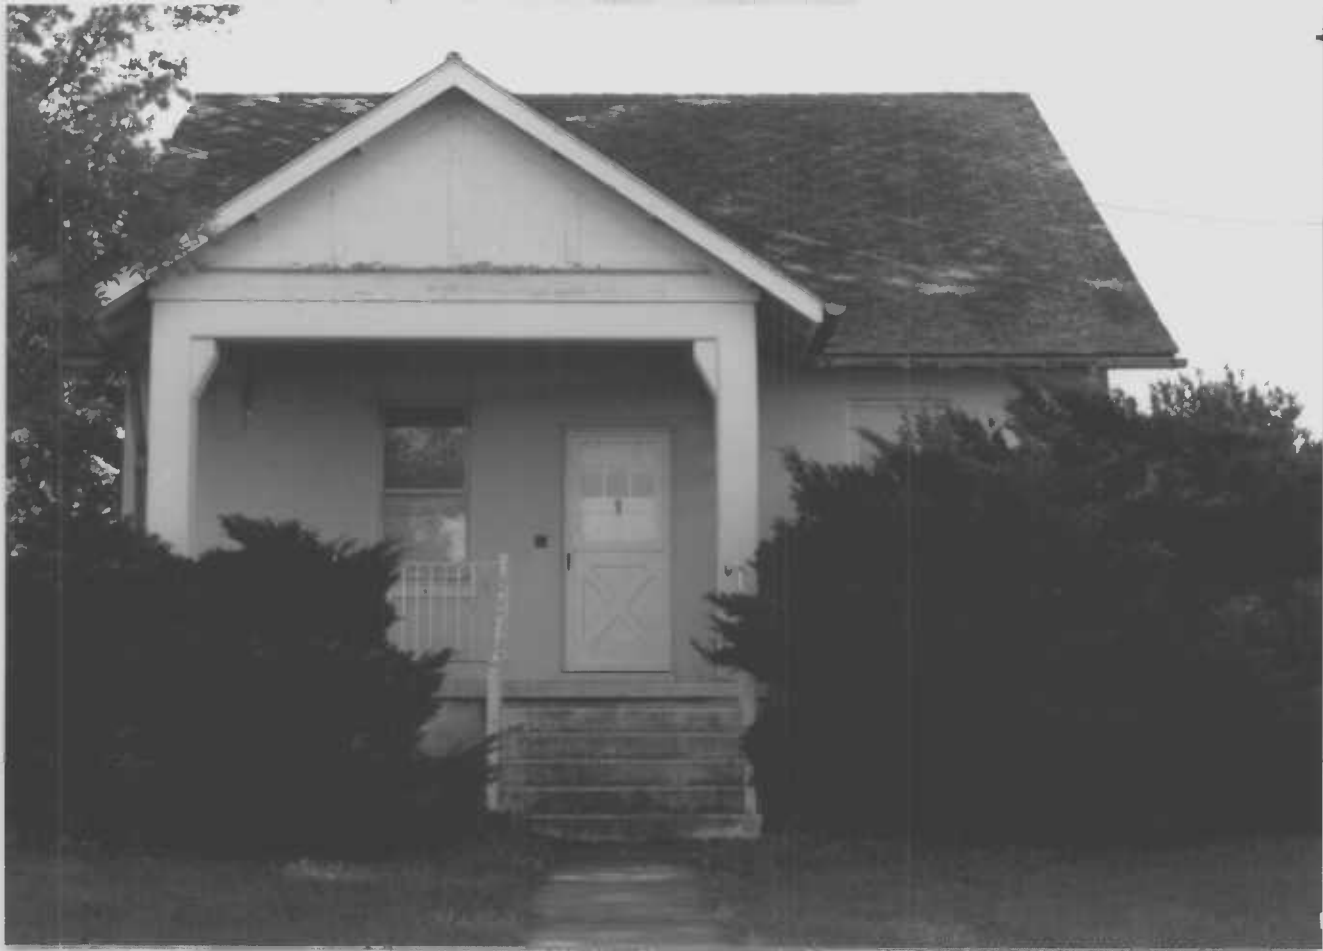
1 OF 5

PHOTO BY REGINA ARLOTTO, JULY 1996
NEGATIVE AT MD SHPO
NORTH FACADE (FRONT)

The principal (north) facade, which fronts on Powder Mill Road, features an open, concrete-slab entrance porch covering two-thirds of the elevation. The entrance porch has Craftsman-style decorative brackets where the porch supports meet the roof. The front door is centered on this elevation, and is flanked by irregularly placed, one-over-one, double-hung windows. The front door is paneled and has a six-light window, and is obscured by a modern metal storm door. A flight of five concrete steps leads to the porch. The porch and stairs are enclosed by a metal railing. A wooden trellis covers the south porch opening.

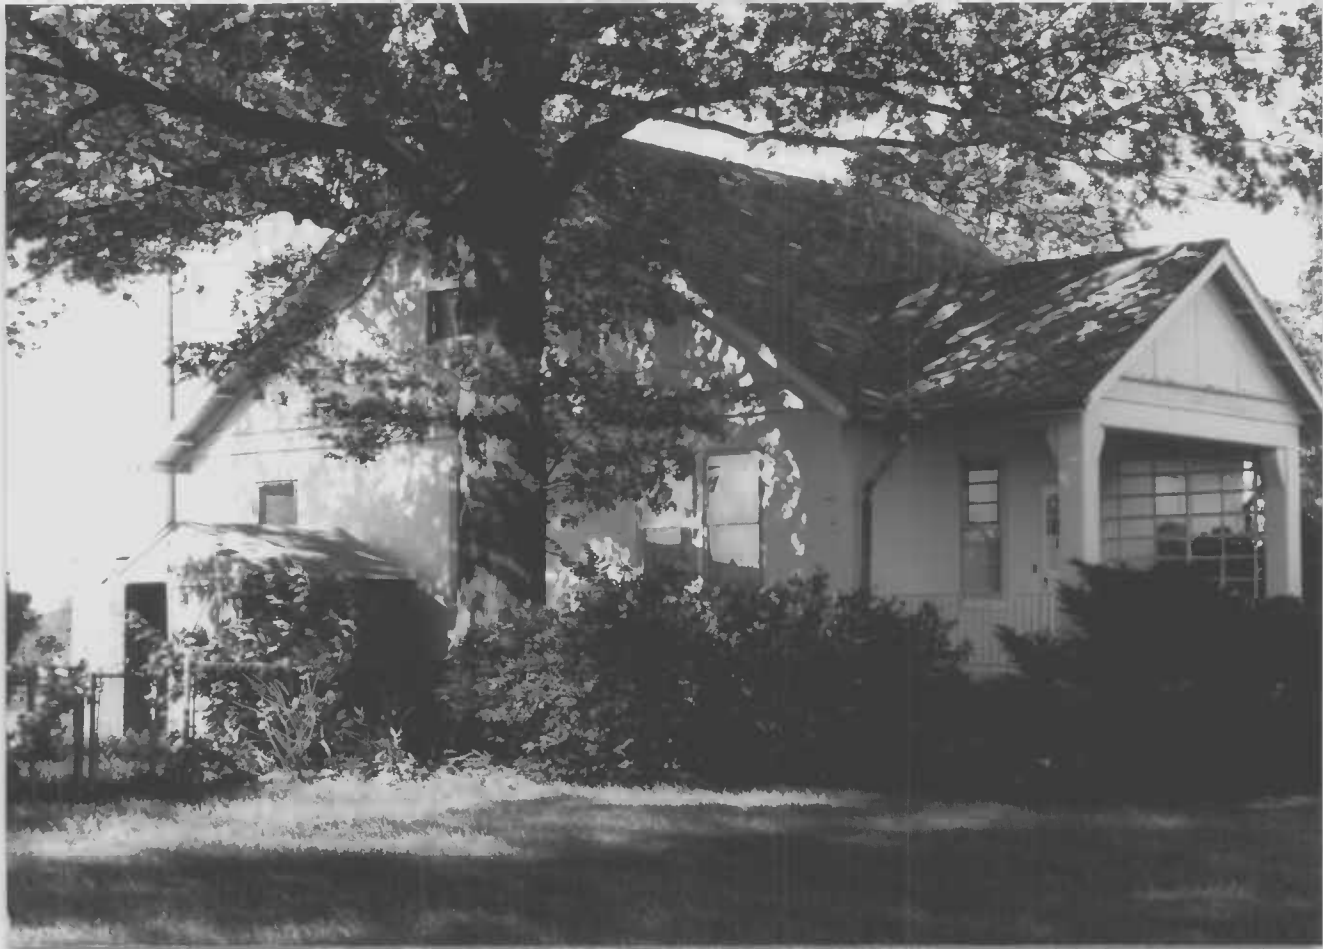
2 OF 5

EAST FACADE, LOOKING WEST

The east elevation is partially covered by a small wooden shed that appears to be of later vintage. There are four, one-over-one, double-hung windows on the first story. Two of the windows are placed singly, and the other two windows at the front of the house are paired. A single, one-over-one, double-hung window is centered in the gable on the second story.

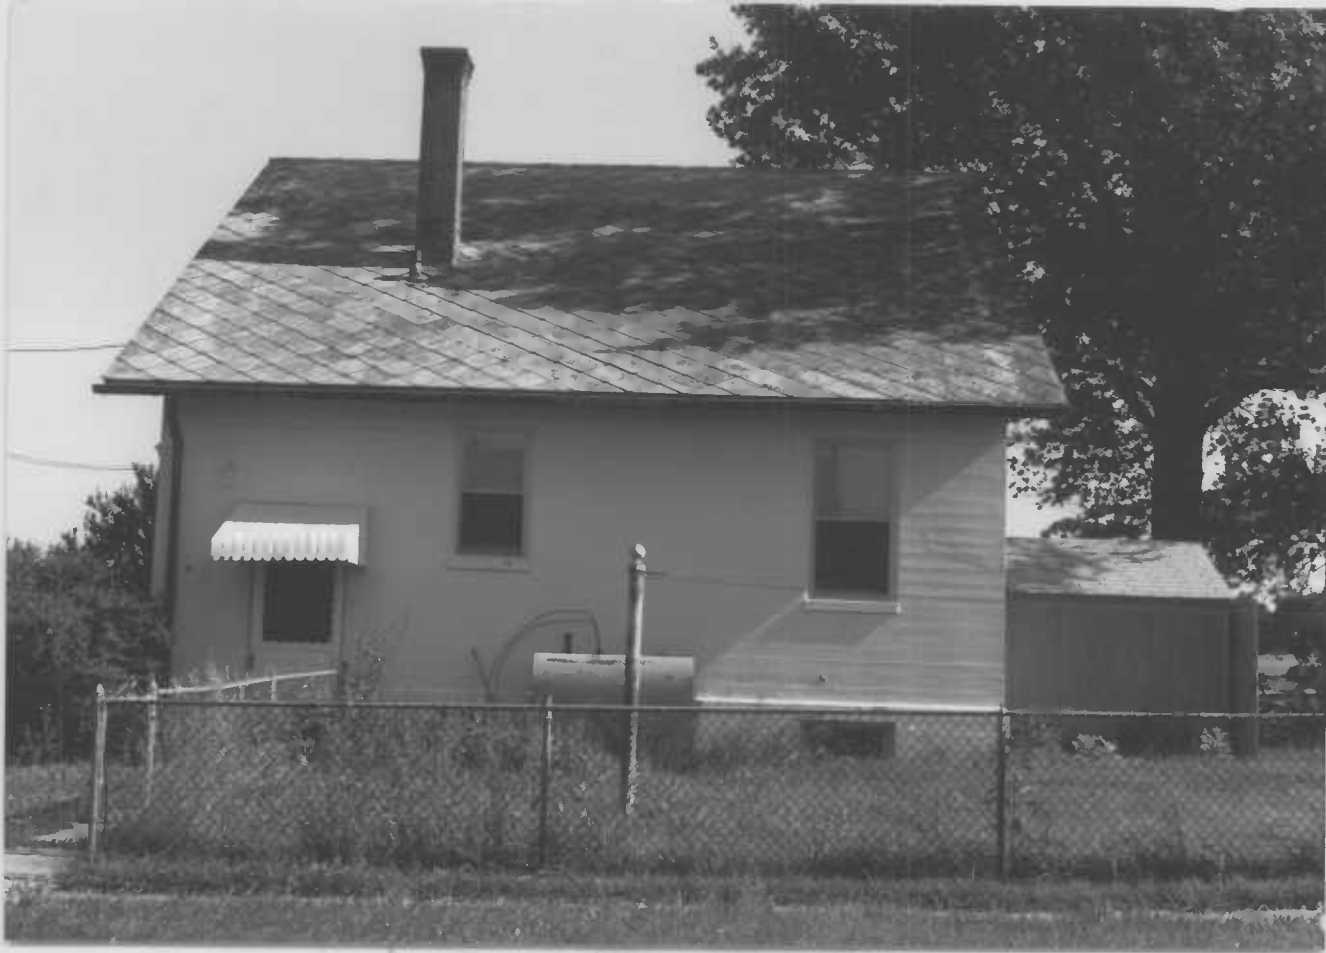
3 OF 5

SOUTH FACADE LOOKING NORTH

The south elevation has a single door topped with a small awning. There are two irregularly placed windows on the first story of this elevation; the eastern window is slightly smaller than the western window. There is one small single-paned window located in the building's foundation, directly under the larger western window.

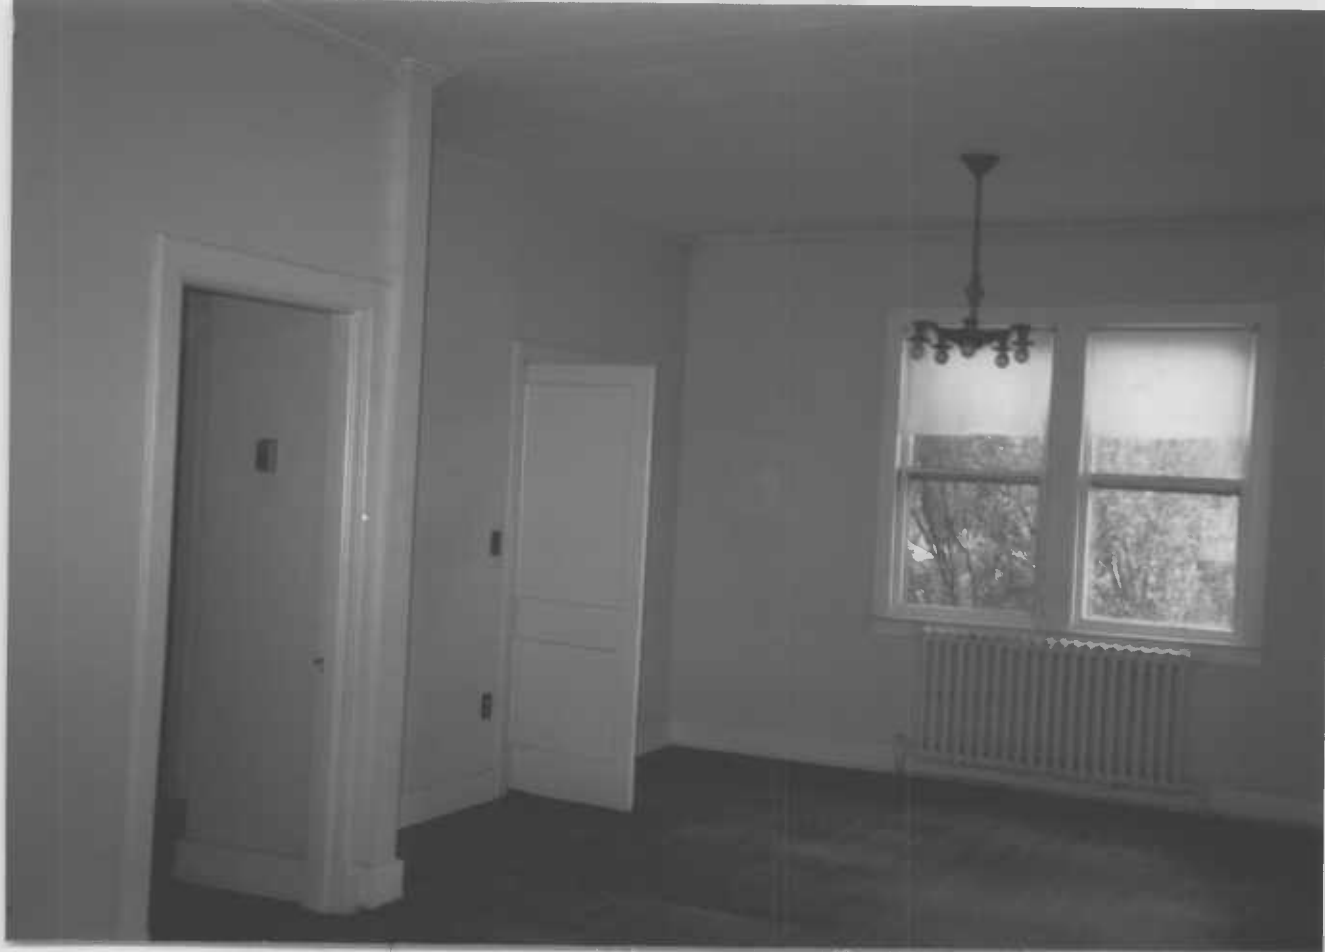
4 OF 5

INTERIOR, VIEW OF LIVING ROOM

The front door leads into a large room spanning the front of the house from east to west. This room is characterized by multiple windows and multi-light hanging fixtures. Radiators are located under every window. A central hall leads to the rear of the house, where a central staircase provides access to the upper

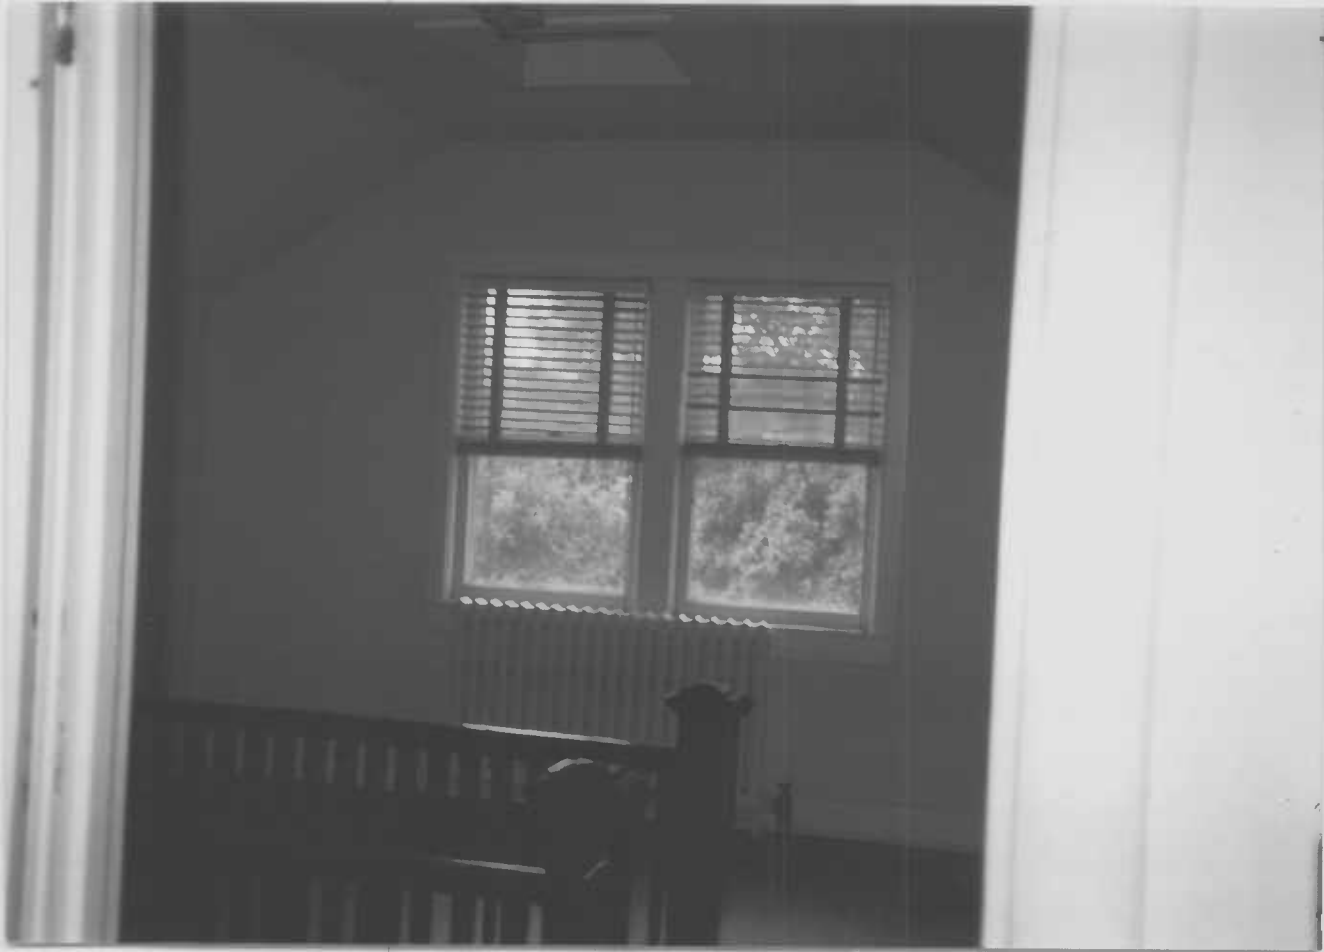
INTERIOR, VIEW OF SECOND FLOOR LOOKING EAST
5 OF 5

The upstairs opens directly into one room located under the eaves and lit by a double window. The second room is located along the east side of the house, also lit by a window.
